T-771
Philip Harris House
Bellevue
Private

Resource Name: PHILIP HARRIS HOUSE

MHT Inventory Number: T-771

Maryland Historical Trust State Historic Sites Inventory Form

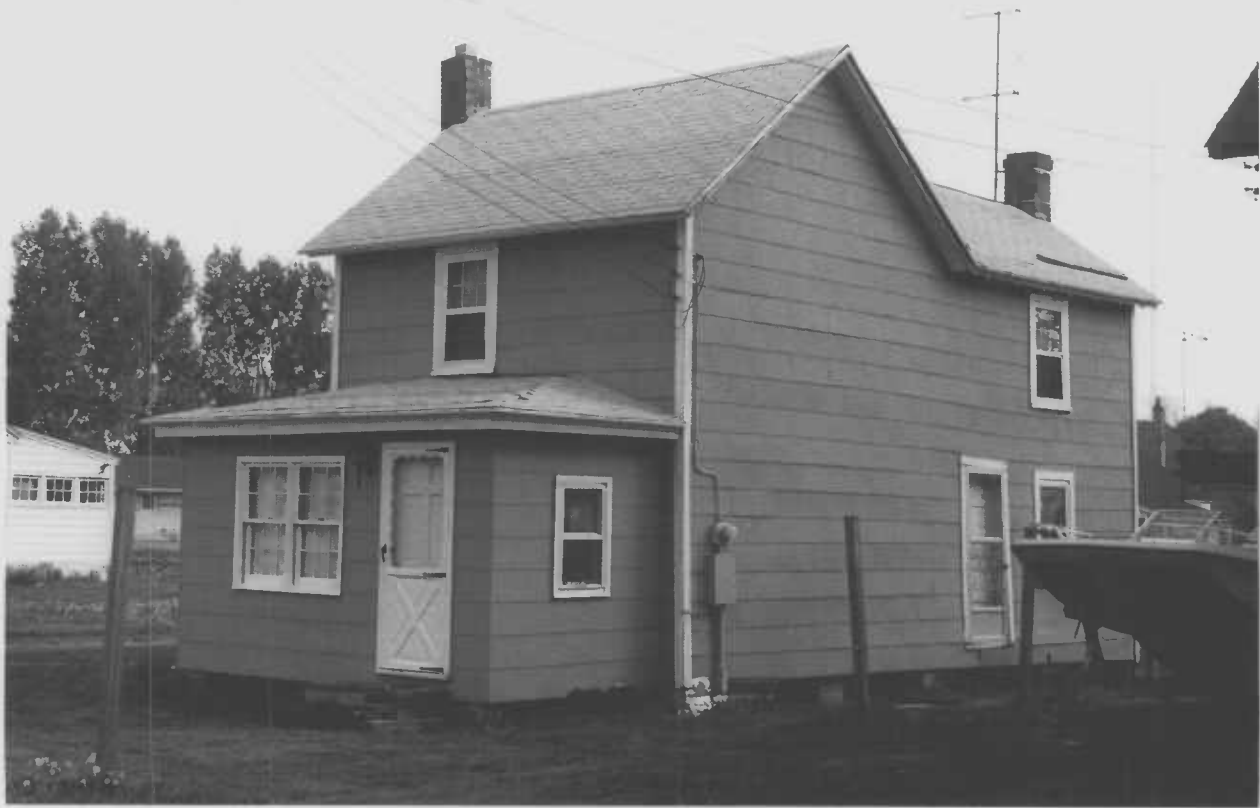
T-771

The northeast (main) elevation is partially obscured by an enclosed hip roof porch. The second floor is marked by an off-center six-over-six sash window.

Northeast elevation
